Manhole Inspection Summary

Manhole # S39C2_019MH

Location Address: **4033 6th St**

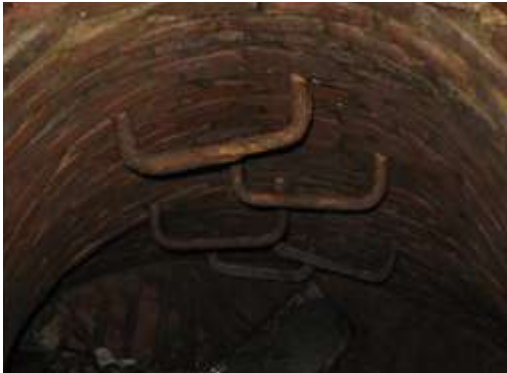
Steps Count: **5** Missing: **0** ☒ **Corroded**

steps

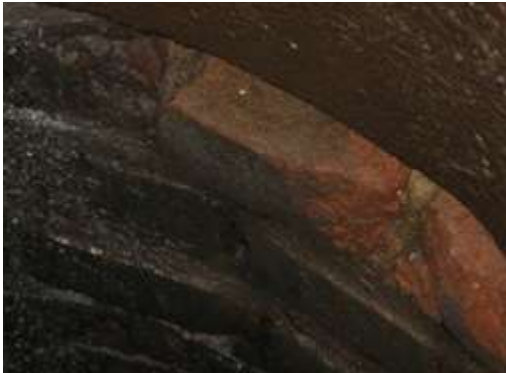
Defect 1

Condition: ☐ Sound ☐ Cracked ☐ Root Intrusion ☒ **Loose Brick** ☐ Deteriorated

loose bricks on chimney

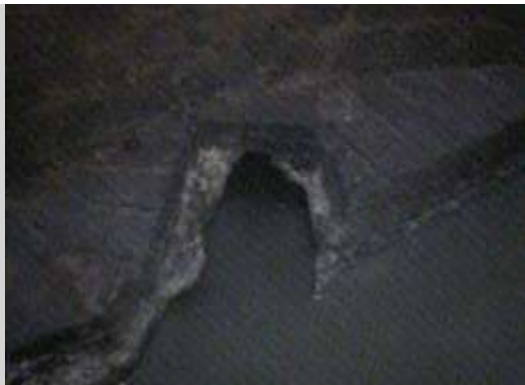
4 O'Clock Inflow

6 in. Circular Service Sewer
Pipe In @ 4 O'Clock

Pipe Height: **7.2** (in.) Rod and Bar (Angled)
Pipe Material: **Clay** ☐ Pipe Lined
Invert Depth: **10.31** (ft.) Flow Characteristics: **Fast**
Deposits: ☒ None ☐ Mud ☐ Sludge ☐ Debris ☐ Grease
Silt Depth: (in.) Deposits Extent:
Infiltration: **None** Pipe Seal Cond: **Broken**
